# DAM SAFETY INSPECTION REPORT

**NAME OF DAM:** Cowpath Dam

**DATE:** 6/8/2021

NAME OF DAM: Sullivan

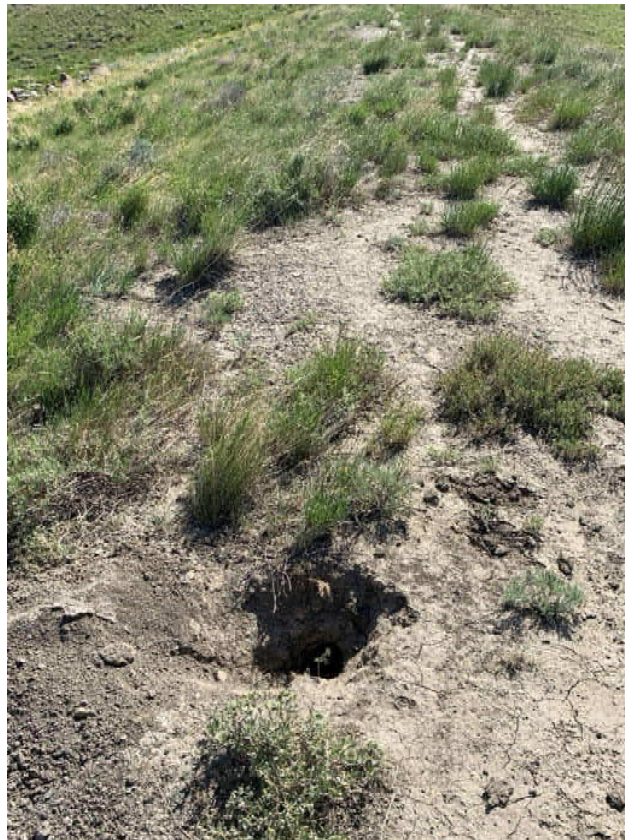
PHOTO 2

Badger Hole on  
Sullivan Dam  
Crest

RECOMMENDATIONS		
Maintenance/Repair		
ID	Description	Status
1:C:9	Provide Rodent Control	
1:B:11	Grease and cap at structure	
2.A.5	Ensure Toe Drain Outlet is Unobstructed	
Multiple	Monitor Noted Erosion Areas	
Annual Maintenance		
ID	Description	Status
3.A.11	Lubricate and Operate Spillway Gate	
2.B.1	Monitor Water Levels Below Outlet Structure

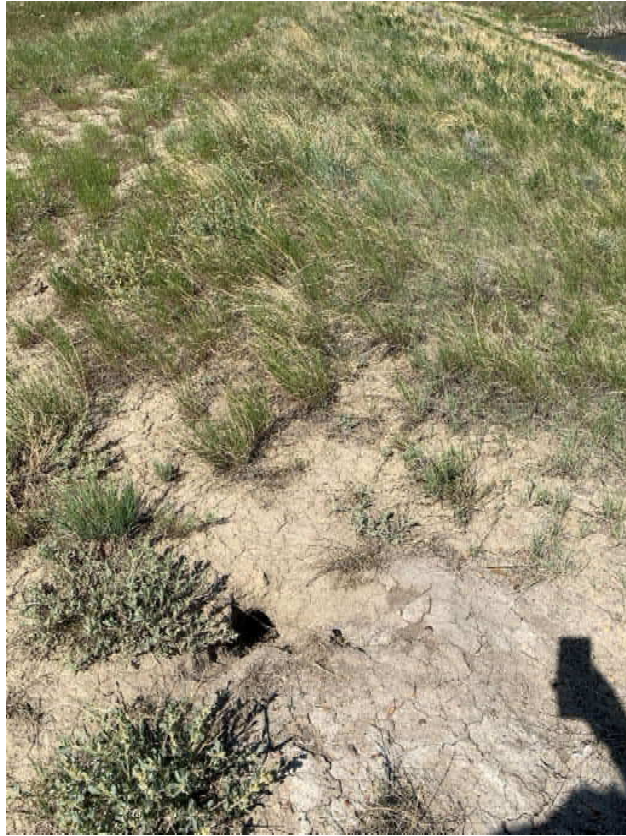
PHOTO 3

Rodent Hole on  
Sullivan Dam  
Crest

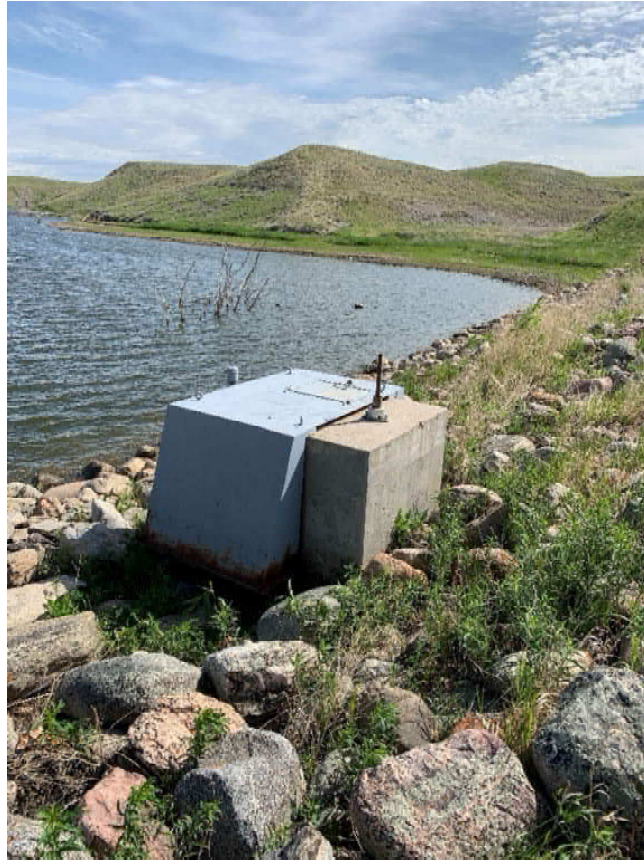
PHOTO 5

#	ITEM	YES	NO	REMARKS
1	Settlement	<input type="checkbox"/>	<input checked="" type="checkbox"/>	
2	Concrete Cracking	<input checked="" type="checkbox"/>	<input type="checkbox"/>	Minor cracking of concrete outlet structure
3	Concrete Spalling	<input checked="" type="checkbox"/>	<input type="checkbox"/>	Minor spalling at outlet
4	Concrete Erosion	<input type="checkbox"/>	<input checked="" type="checkbox"/>	
5	Exposed Reinforcement	<input type="checkbox"/>	<input checked="" type="checkbox"/>	
6	Joint Displacement	<input type="checkbox"/>	<input checked="" type="checkbox"/>	
7	Problems with Trash Rack	<input type="checkbox"/>	<input checked="" type="checkbox"/>	
8	Corrosion of Trash Rack	<input type="checkbox"/>	<input checked="" type="checkbox"/>	
9	Erosion Around Intake	<input type="checkbox"/>	<input checked="" type="checkbox"/>	
10	Deposition Around Intake	<input type="checkbox"/>	<input checked="" type="checkbox"/>

Sullivan Dam  
Outlet Structure

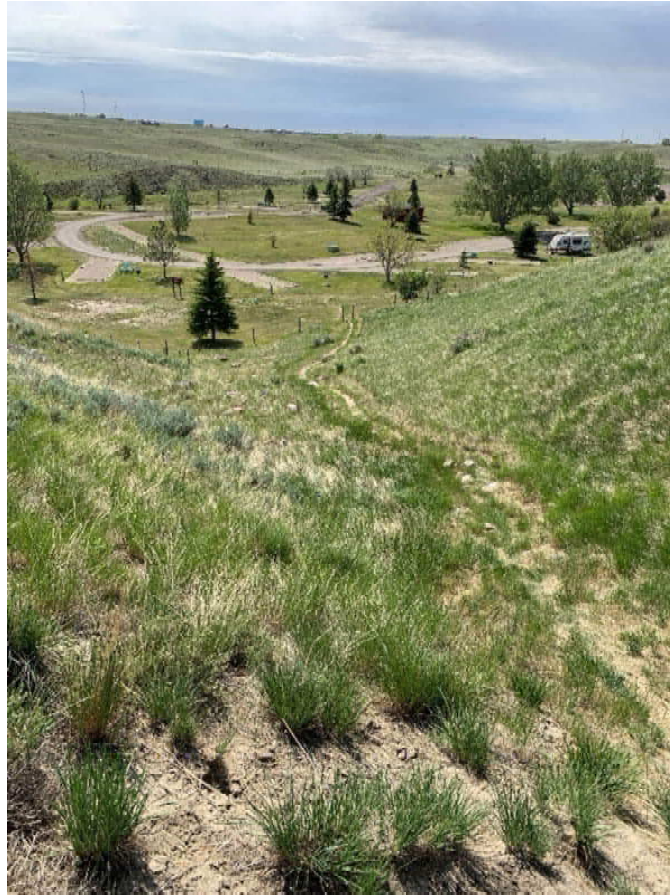
PHOTO 9

#	ITEM	YES	NO	REMARKS
1	Erosion	<input checked="" type="checkbox"/>	<input type="checkbox"/>	Minor erosion along groin

Sullivan Dam  
Downstream West  
Groin

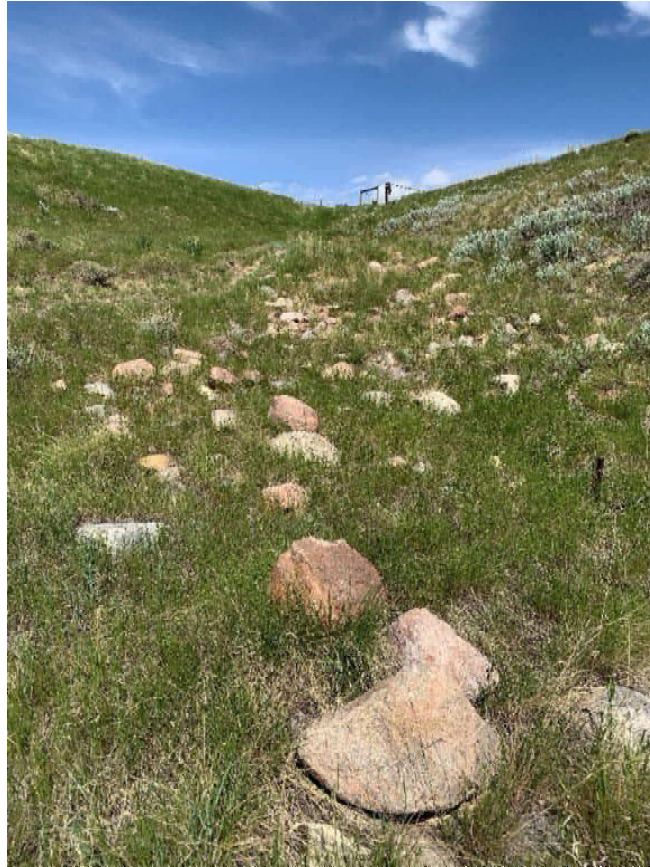
PHOTO 11

Sullivan Dam  
Downstream West  
Groin

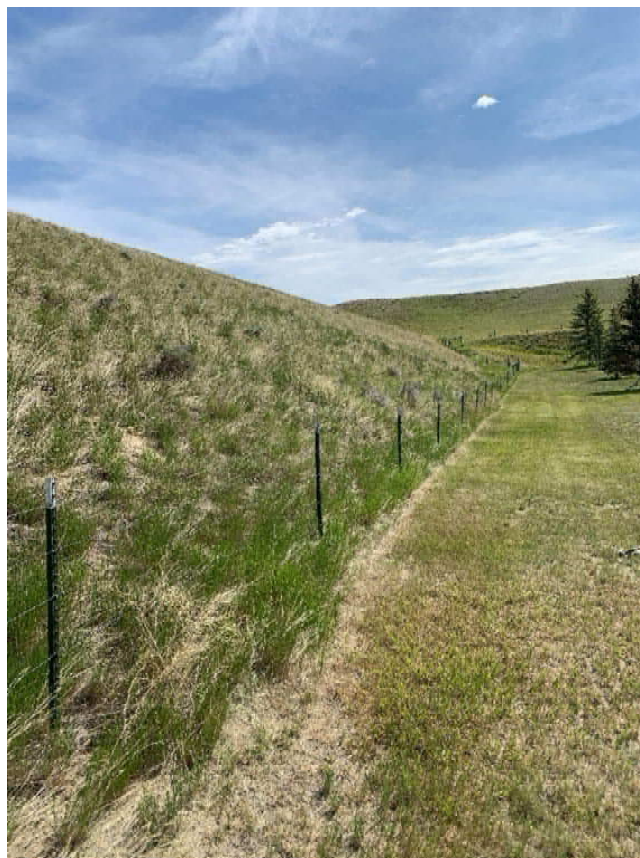
PHOTO 12

#	ITEM	YES	NO	REMARKS
1	Seepage	<input checked="" type="checkbox"/>	<input type="checkbox"/>	Standing water below outlet structure, no seepage observed along remainder of toe
2	Depressions/Bulges	<input type="checkbox"/>	<input checked="" type="checkbox"/>	
3	Boils	<input type="checkbox"/>	<input checked="" type="checkbox"/>	
4	Toe Drain in Good Condition	<input type="checkbox"/>	<input type="checkbox"/>	Not able to observe toe drain, appears to discharge into channel below primary spillway
5	Toe Drain Flowing	<input type="checkbox"/>	<input type="checkbox"/>	Phase 1 inspection 1980, "The toe drainage extends along the length of the embankment and discharges into the stilling basin (Plate 3). The dam is composed of a sand-gravel mixture, and is shown to be 3 feet deep and 5 feet wide on the design cross-section Although the material did not meet specifications, it appears to function adequately. The seepage is collected adjacent to the spillway outlet and piped into the stilling basin At the time of our investigation there was a trickle of water flowing from the outlet."

Sullivan Dam  
Downstream Toe

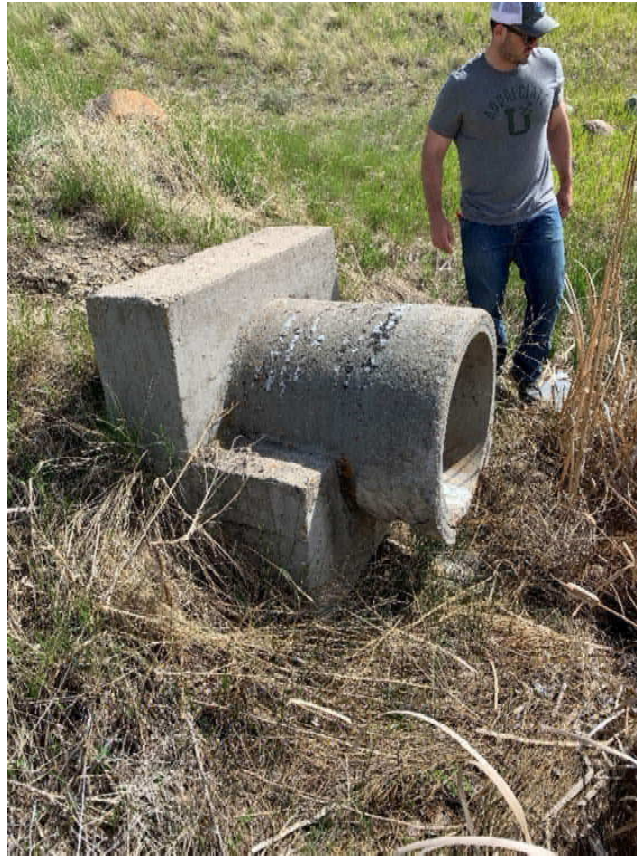
PHOTO 13

Sullivan Dam  
Primary Spillway  
Outlet Structure

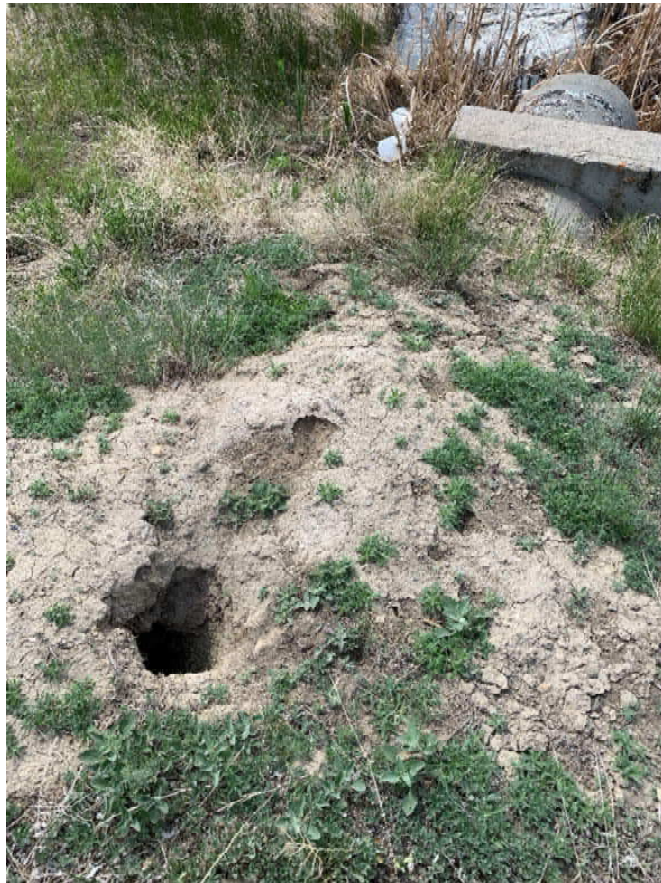
PHOTO 17

Sullivan Dam  
Primary Spillway  
Rodent Hole  
Above Outlet  
Structure

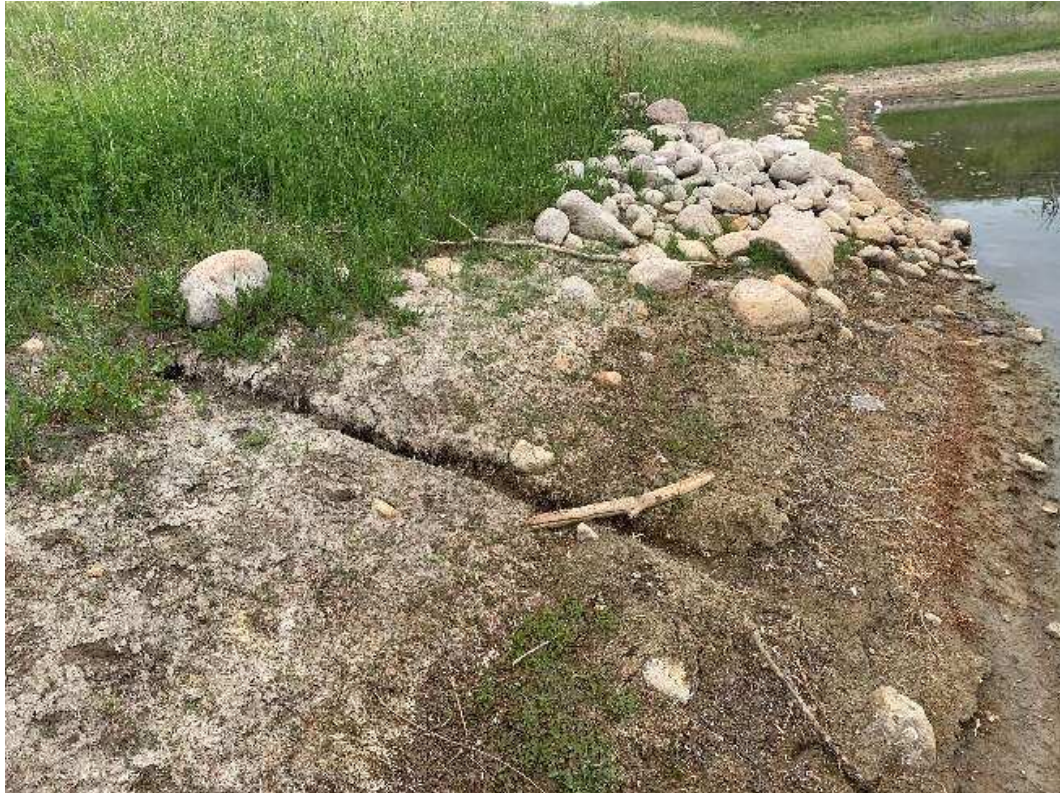
PHOTO 35

Cowpath Dam  
South Rodent  
Channel

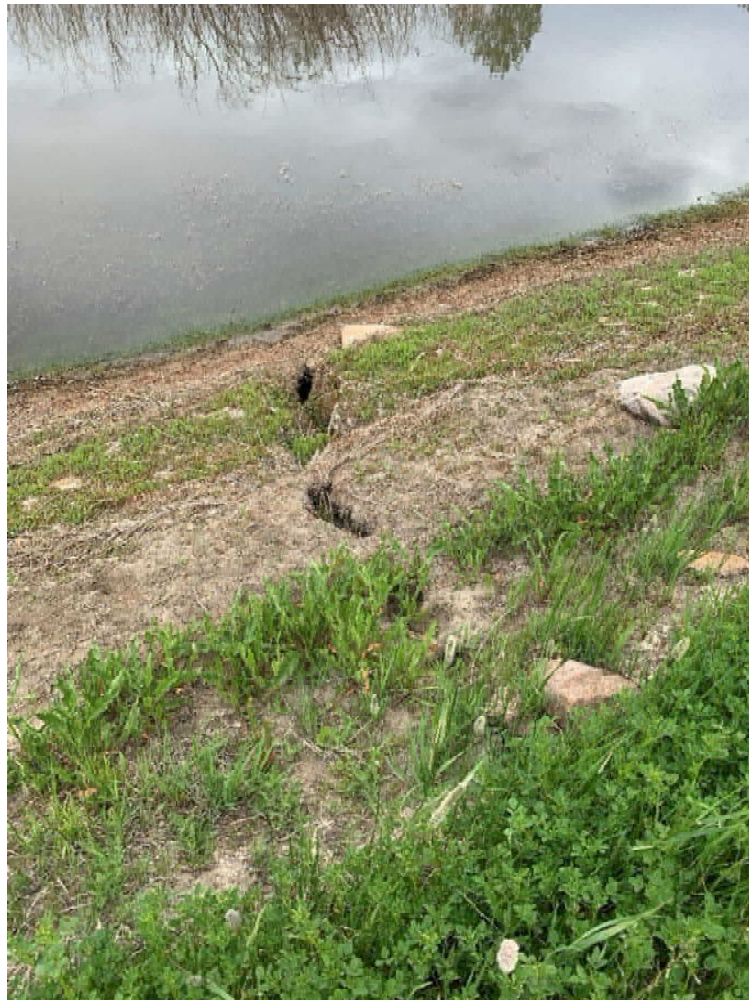
PHOTO 36

Cowpath Dam  
South Rodent  
Channel

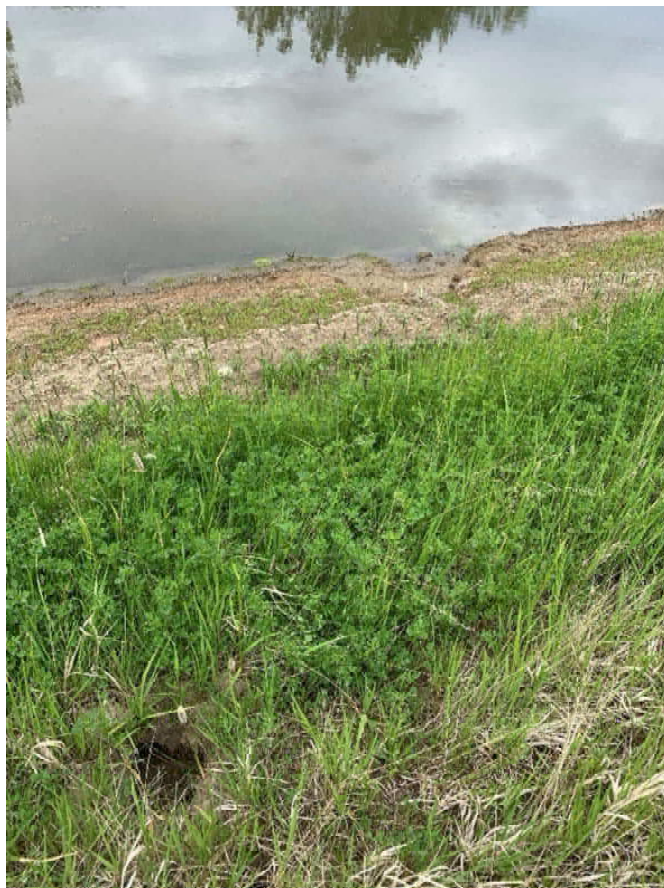
PHOTO 38

Cowpath Dam  
South Rodent  
Channel and  
Boring

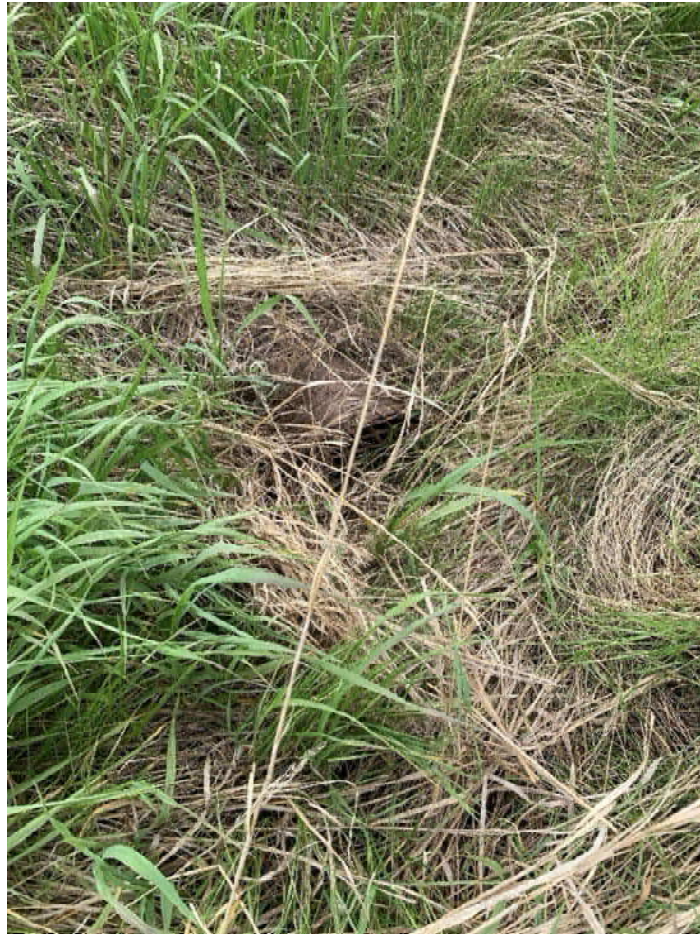
PHOTO 43

Cowpath Dam  
South Underdrain  
Outlet

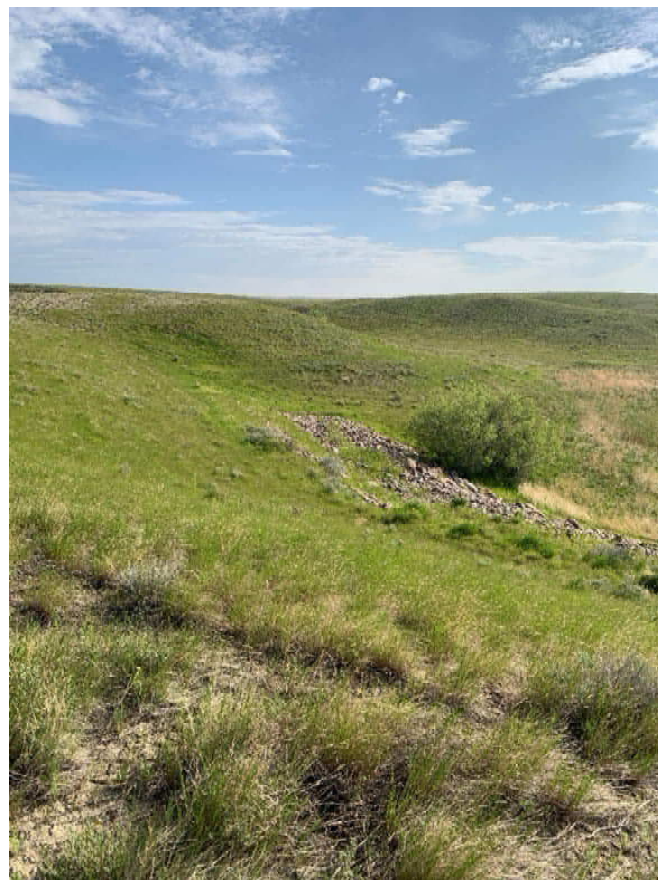
PHOTO 47

Cowpath Dam  
North Tree at Toe  
of Upstream Slope

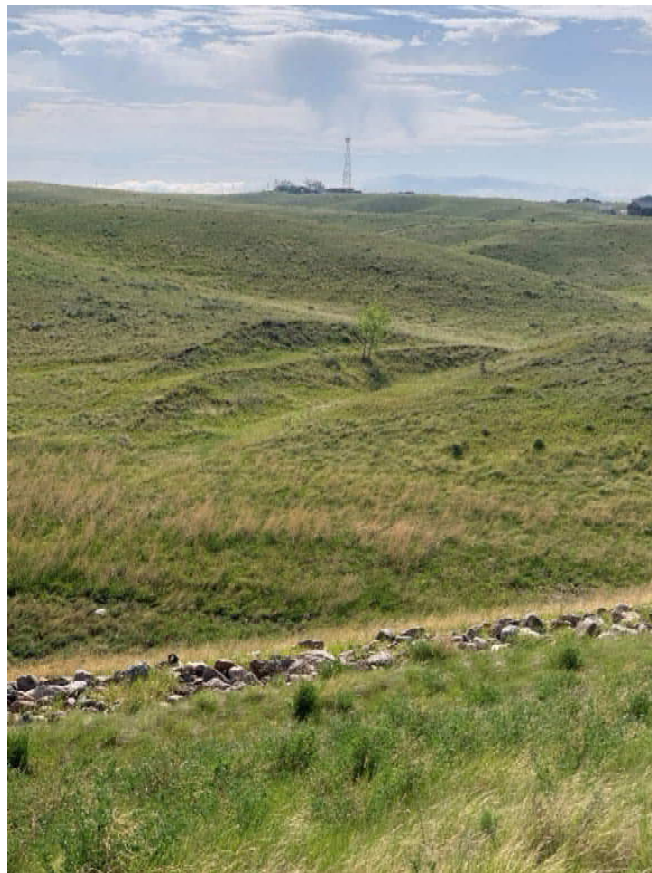
PHOTO 51

Cowpath Dam  
Excavated  
Channel  
Connecting North  
and South  
Reservoir Area

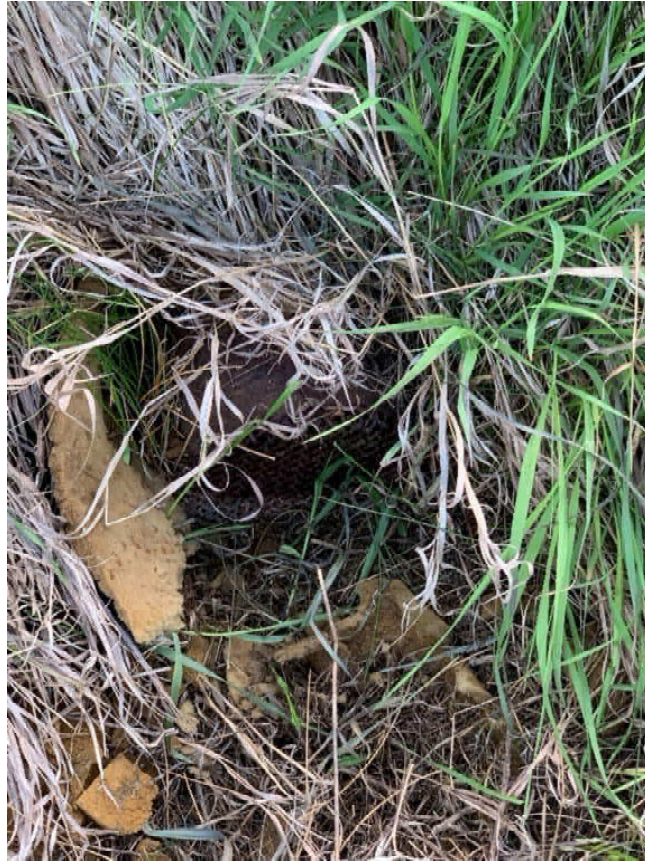
PHOTO 52

Cowpath Dam  
North Toe Drain  
Outlet

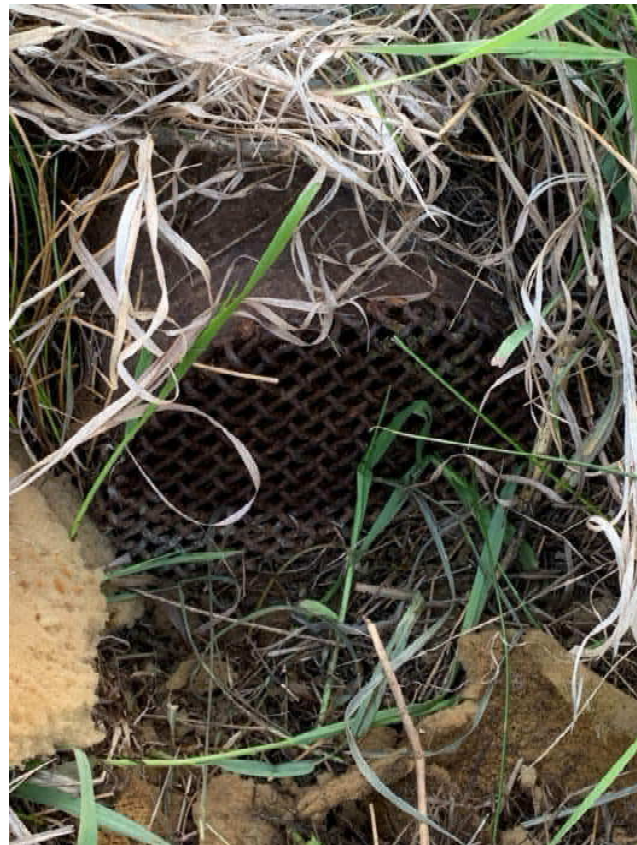
PHOTO 53

Cowpath Dam  
North Toe Drain  
Outlet
