# **Existing Conditions Report**

## **Shelby Master Transportation Plan**

**Shelby, Montana**

January 2014

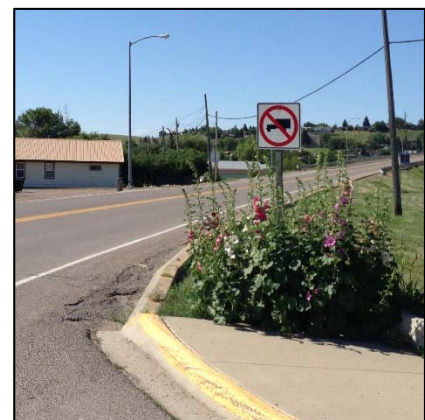
*Figure 9 - Truck Prohibition Sign on Oilfield Avenue Viaduct*

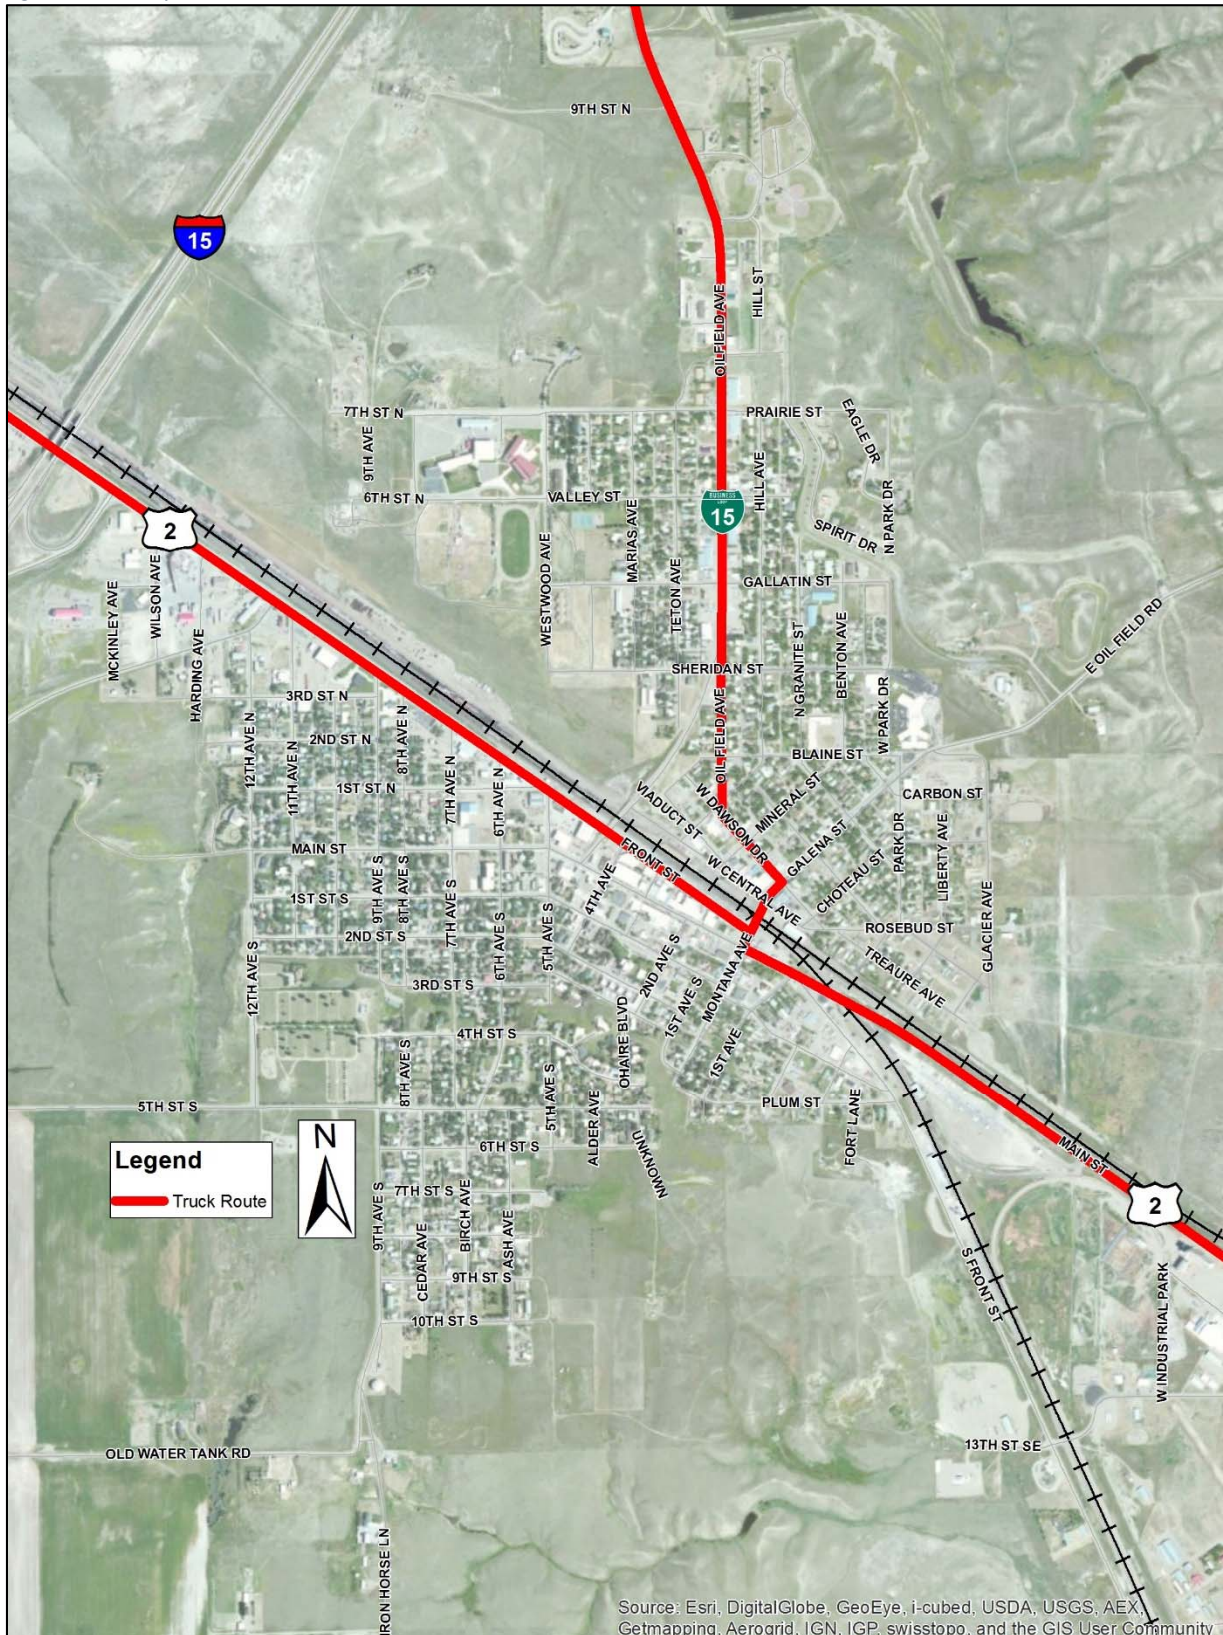
Figure 12 - Shelby Truck Routes

Eastbound/westbound trucks on US 2 through Shelby are directed to bypass Main Street via Front Street and Montana Avenue. Trucks originating from or destined for Oilfield Avenue/I-15 Business Loop are directed to bypass Main Street and the Viaduct via Front Street and Dawson Drive. The truck routes through Shelby can be seen in **Figure 12**.

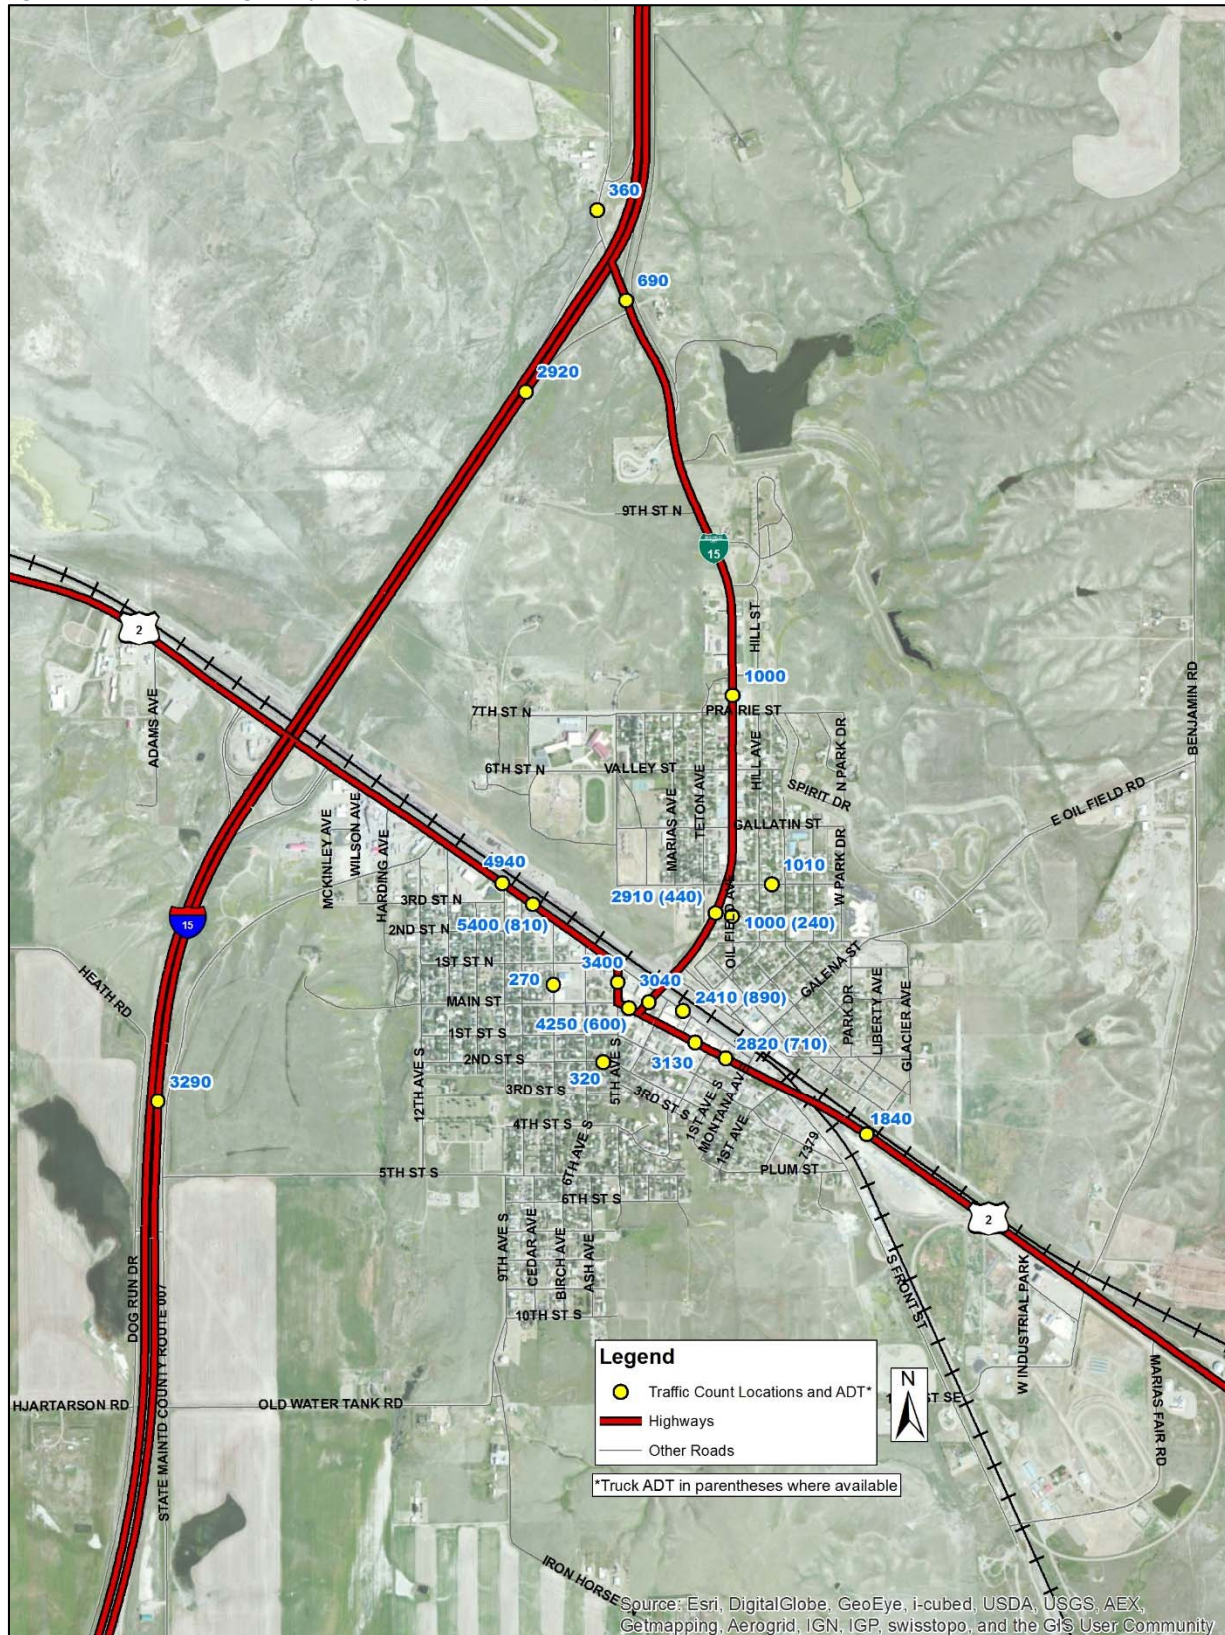
Figure 14 - Recent Average Daily Traffic Volumes (2010-2013)

Recent (2010-2012) average daily traffic volumes (ADT) can be seen in **Figure 14**. ADT information was obtained from the Montana Department of Transportation (MDT), and some ADT information was collected as part of this study.

While through truck traffic is directed to bypass Main Street, many trucks and other large vehicles use Main Street anyway. Based on traffic counts performed in September 2013, approximately 650 trucks per day travel through downtown on Main Street (see **Figure 14**).

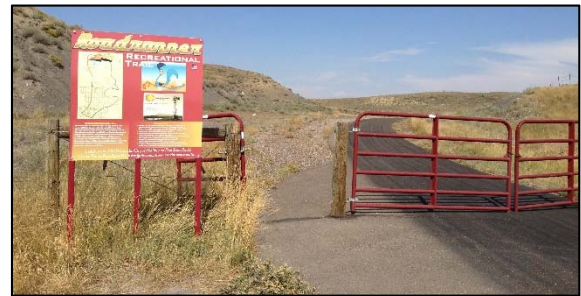
Figure 20 - Shared Use Path on Roadrunner Trail

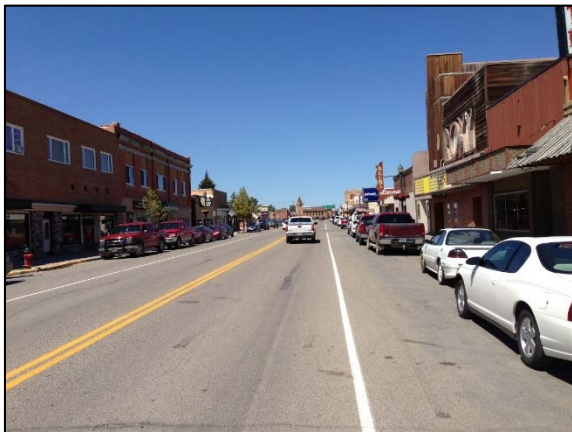
Figure 21 - Wide Parking Lanes on Main Street

Current bicycle facility gaps on Main Street and Galena Street could be filled in by providing on street bicycle facilities (bike lanes or shared lanes) via pavement marking revisions. For example, the parking lanes on Main Street (See **Figure 21**) could be narrowed to provide bicycle lanes in each direction.

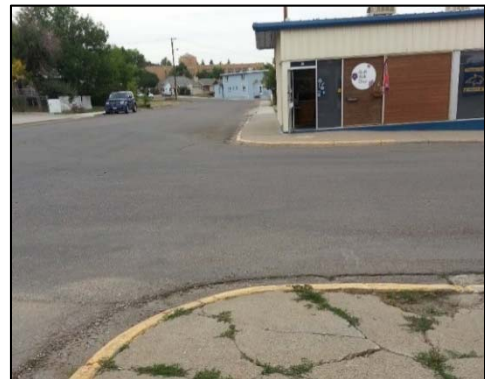
Curb ramps are provided for many pedestrian crossings in Shelby, however there are several locations where curb ramps are not present (see **Figure 24**). The absence of curb ramps can make such crossings difficult or impossible for wheelchair or scooter users to traverse and can also present difficulties to vision impaired pedestrians. Curb ramp improvements can be completed as part of larger scale improvements or can also be programmed on their own based on available funding.

*Figure 24 - Missing Curb Ramps*

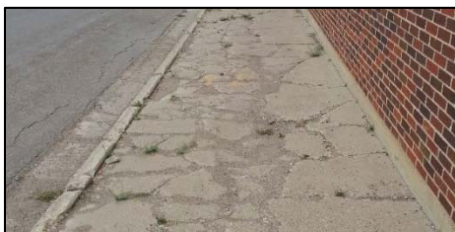
*Figure 25 - Deteriorated Sidewalk*

Sections of deteriorated sidewalks (see **Figure 25**) were also identified. Deteriorated sidewalks can be difficult for wheelchair users and vision impaired pedestrians to traverse. Badly deteriorated sidewalks should be repaired or replaced to ensure they can be used by all pedestrians.

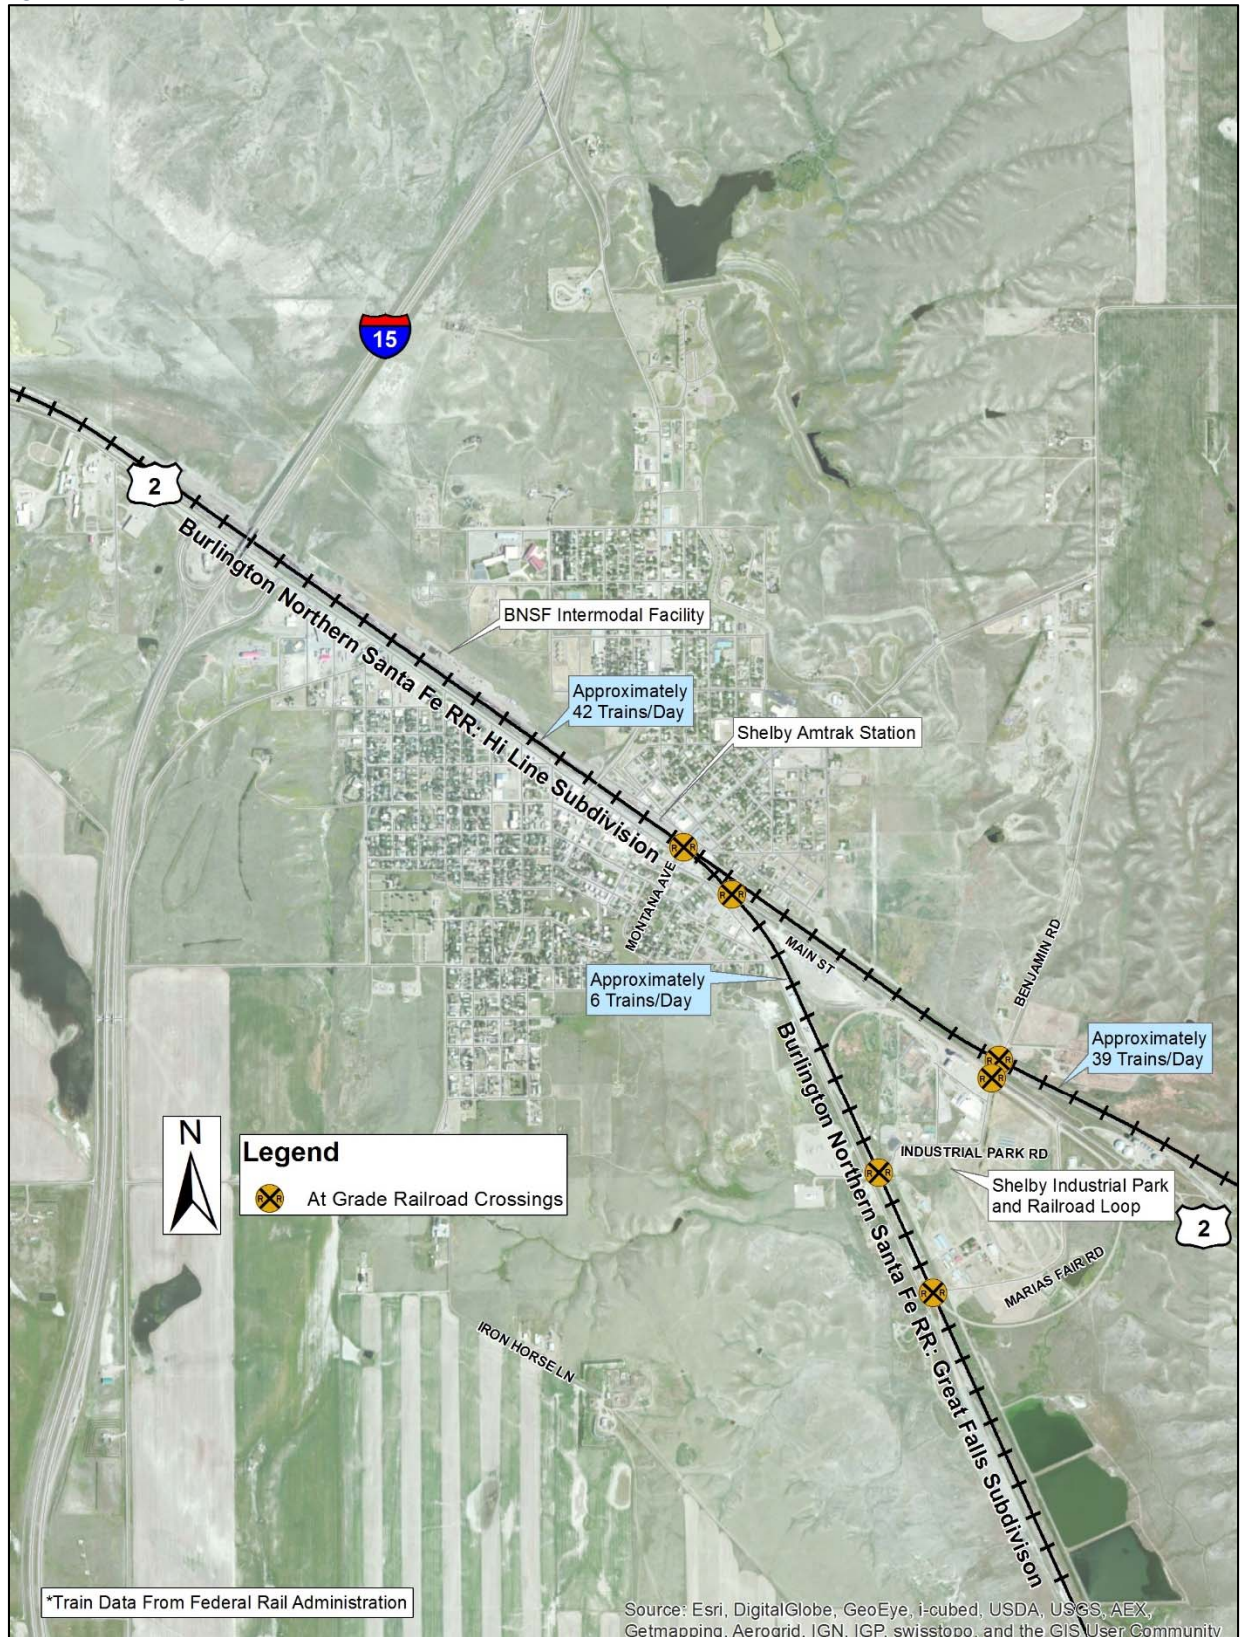
Figure 28 - Existing Railroad Facilities

The existing railroad facilities in Shelby can be seen in **Figure 28**.

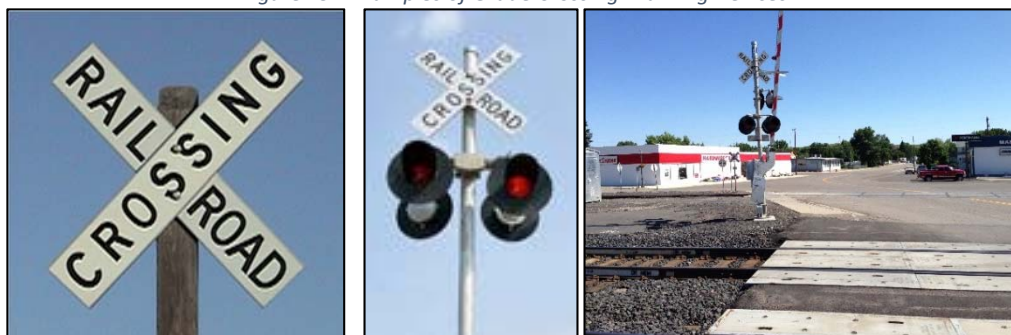
*Figure 29 - Examples of Grade Crossing Warning Devices*

A review of guidelines in the FHWA *Railroad-Highway Grade Crossing Handbook* indicates that the existing warning devices at each crossing are sufficient. Additional measures would however need to be taken if the implementation of a railroad quiet zone is desired. Trains would not be permitted to sound their horns while passing through Shelby if a quiet zone was implemented. Shelby does not currently have a railroad quiet zone.
